Case Report

Journal of Dental Science, Oral and Maxillofacial Research

Broken file: bypass or ultrasonic removal technique

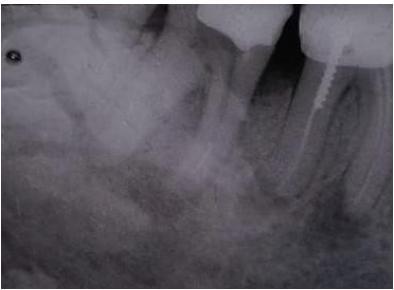
The radiographic examination (Figure 1) reveals the presence of a 4mm instrument which blocks the apical third of the M°B root

presenting radiologically a clear X-ray image covering the apex of this root.

Figure I Pre-operative radiograph.

In front of this periapical lesion, we were obliged to push canal disinfection and disorganize the biofilm which adheres to the root walls essential for the healing of periapex. The instrumental fracture in this case constitutes a real obstacle to the success of the endodontic treatment of this tooth. In order to be able to instrument and decontaminate the part of the canal beyond the instrumental fracture, we decided to have this instrument removed from the canal.

In order to be able to instrument and decontaminate the part of the canal beyond the instrumental fracture, we decided to remove this instrument from the canal.

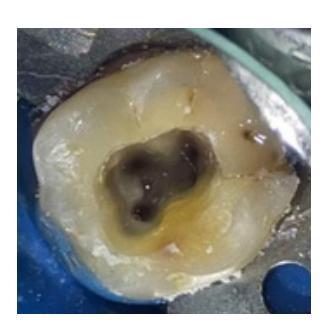
Figure 2 Access cavity.

Briefly, rubber dam isolation and access cavity allowing for straightline access were performed (Figure 2).

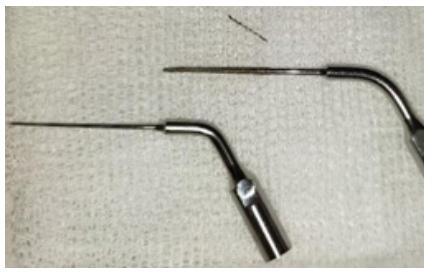
Figure 5 ET25/ ultrasonic diamondtips/ removed broken file.

Fine ultrasonic tips (ET25/ET20; Satelect Corp) were then used to trephine 2mm around the broken file. Subsequently using the tip of the insert the instrument is vibrated with ultrasonic waves counterclockwise inorder to raise it outside the root canal. (Figure 5).

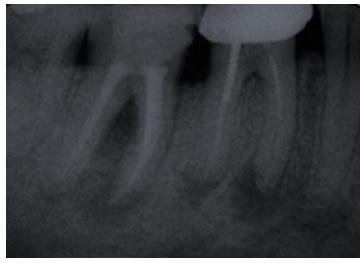
Figure 8 Postoperative X-ray.

A retro alveolar X-ray is then performed to ensure the complete elimination of the fractured instrument and the patency of the canal (Figure 6). Once the canal is again permeabilized, canal shaping and disinfection are reset. Cone fit and postoperative radiographs were performed showing the complete release and obturation of the canal (Figure 7&8).

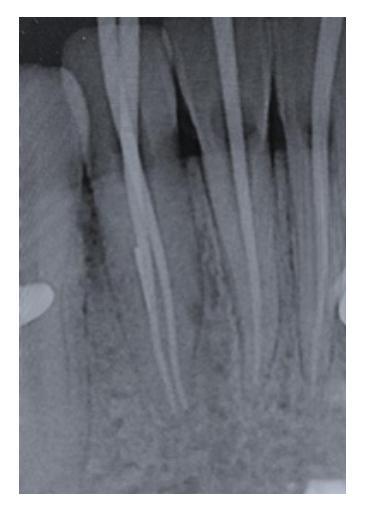
Figure 9 Cone fit radiograph.

for working length determination, the apex locator may give false readings since the fractured instrument is a conductive alloy, so we instrumented the canal according to the predetermined length and the exact value was determined with accuracy after the realization of X-ray file in place and the cone fit radiograph. (Figure 9) after abundant irrigation and ultrasonic activation of 5% NAOCL and 17% EDTA, the obturation was performed and a postoperative X-ray shows that the instrument was well contoured and coated (Figure 10).

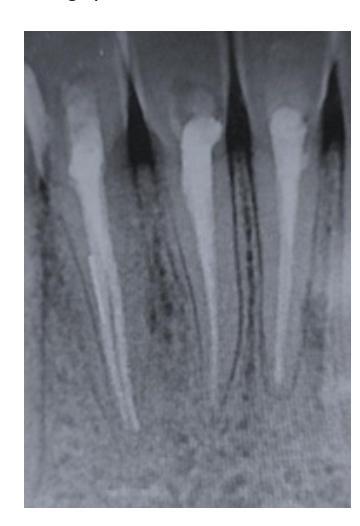
Figure 10 Postoperative radiograph.

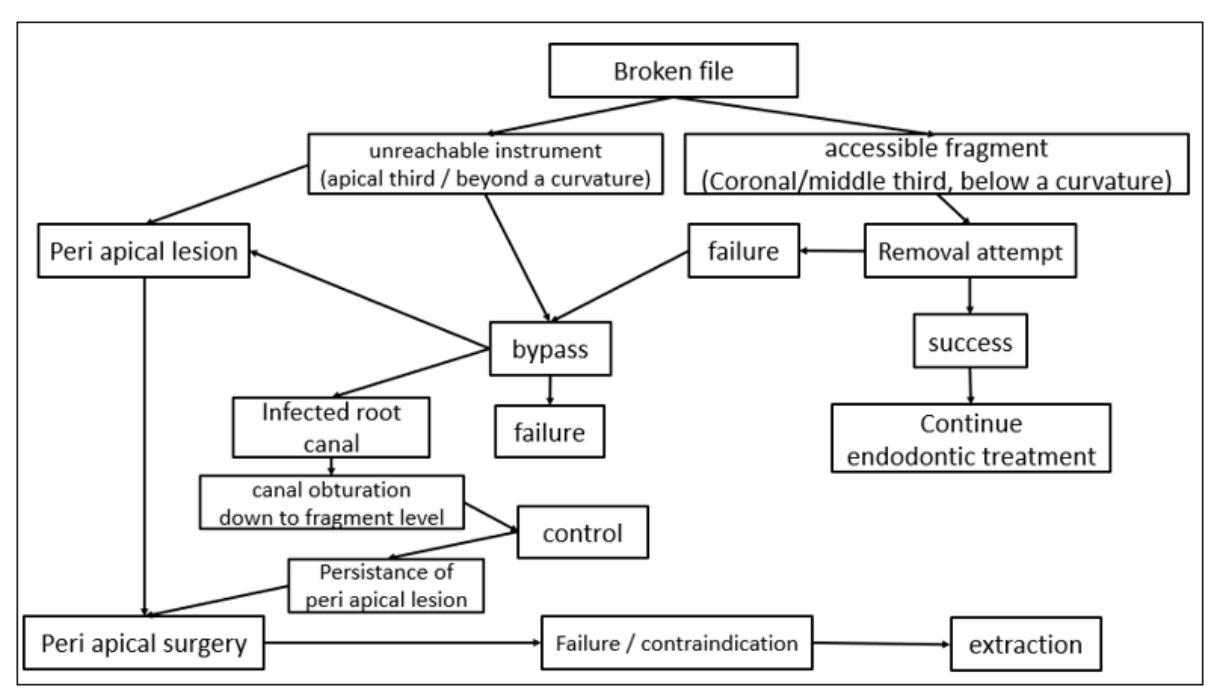
Figure 11 Decision-making charter.

In order to facilitate the therapeutic decision with respect to a fractured instrument, a decision-making charterhas been drawn up (Figure 11).
